DWER CONSULTING

Historic Defects in Buildings

Introduction

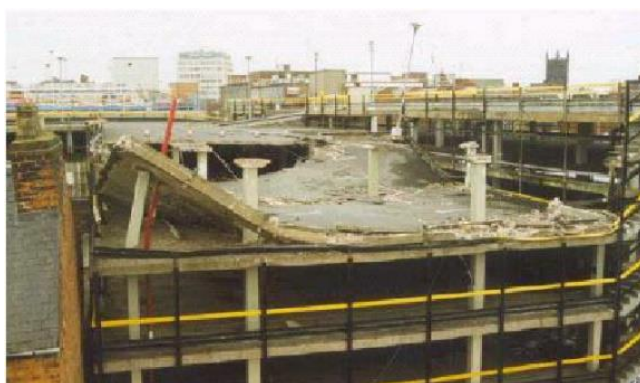
For example, carbonation of the concrete cover to the steel reinforcement, leading to corrosion, was identified as one of the contributing factors to the collapse of the Pipers Row Multi-Storey Car Park in Wolverhampton. On the night of 20 March 1997, a 120 tonne section of the top floor of the car park, built in 1965, collapsed as a result of an initial punching shear failure which developed into a progressive collapse.

Pipers Row car park after the collapse

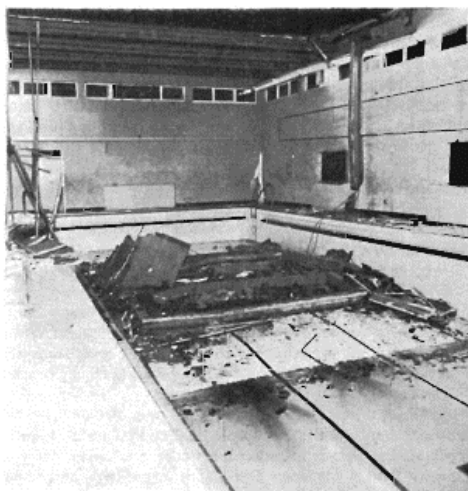
Cass School pool after roof collapse

In the case of the Cass School, failure occurred 18 years after construction. Extensive investigations into these incidents revealed that the conversion, leading to a much reduced strength, of the high alumina cement (HAC) in the precast prestressed concrete beams to these roof structures was the principal cause of collapse.

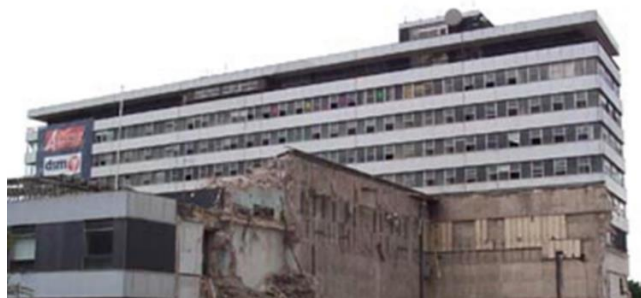
Pebble Mill Studios

- Keybridge House, South Lambeth Road, Vauxhall, London.
- Millennium Stadium North Stand (part of the old National Stadium) Cardiff.
- Merafield Bridge, A38, England. Demolished manually in 2016.
- Pebble Mill Studios, Birmingham. Demolished in 2005
- Royal Devon and Exeter Hospital, Wonford. Demolished and replaced in the mid-1990s.

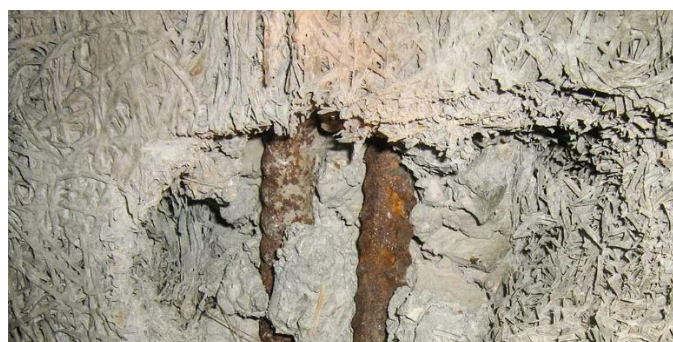
Exposed reinforcement with woodwool formwork

In extreme cases it will be necessary to replace the affected structure; in less severe cases it should be possible to strip out the woodwool and replace the concrete cover using sprayed concrete or other techniques.
